INDOOR AIR QUALITY ASSESSMENT

**Sandisfield Town Offices
66 Sandisfield Road
Sandisfield, MA**

Prepared by:
Massachusetts Department of Public Health
Bureau of Environmental Health
Indoor Air Quality Program
January 2018

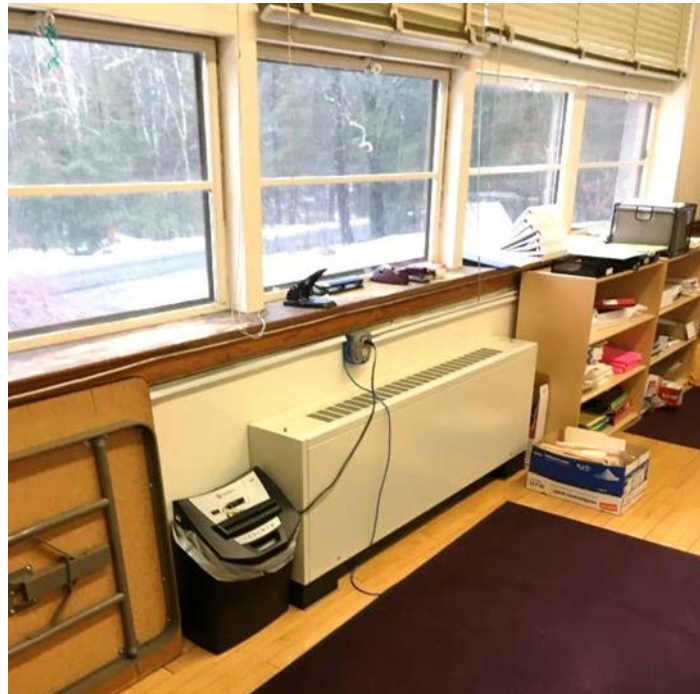
Picture 1

The HVAC system has no mechanical means to provide fresh air. Rooms are equipped with a fan coil unit (FCU) (Picture 1) that provides heat only. It appears that the original ventilation system in the building was removed when the building became town offices. Fresh air intake vents on the outside wall of the building were found sealed (Picture 2). Exhaust vents were also sealed. The sole mean to provide fresh air or to exhaust air is by opening windows.

Fan Coil Unit (FCU)

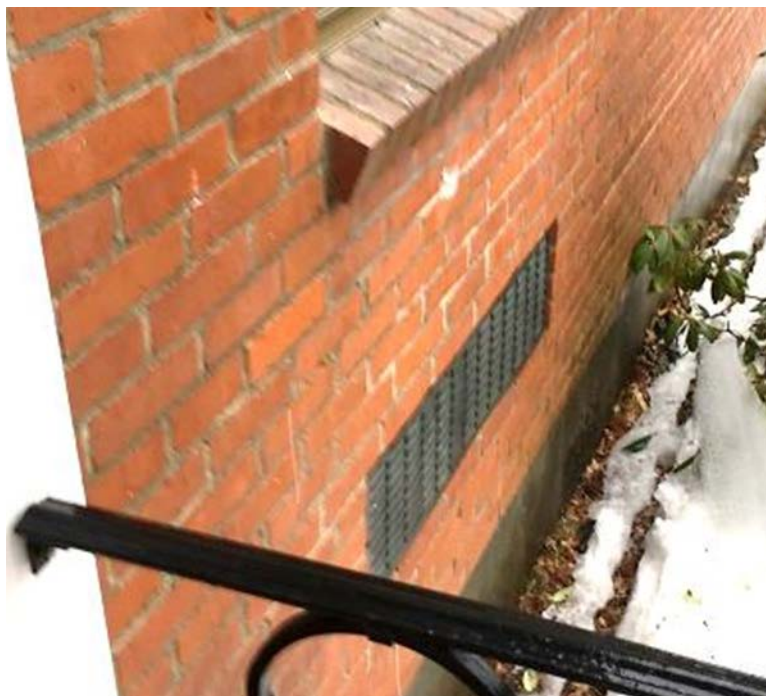
Picture 2

Sealed former fresh air intake

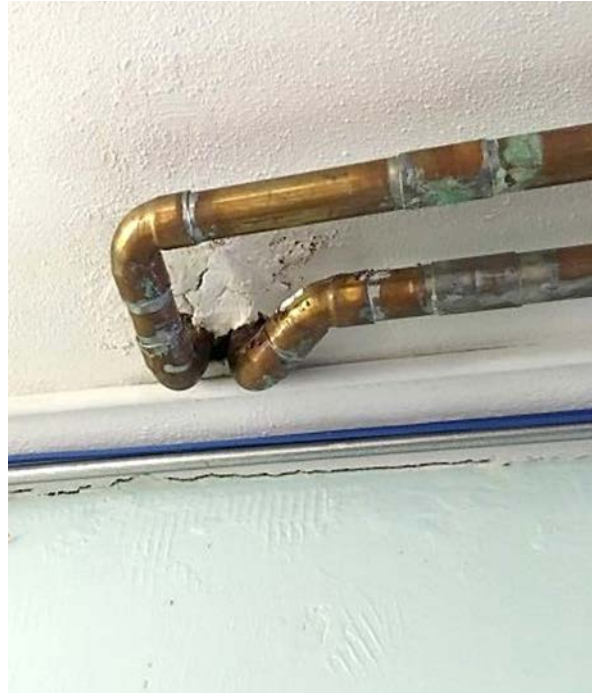
Picture 3

- The heating pipes supplying the Treasurer's Office FCU have a space which opens into the floor space between the Senior Center and the Treasurer's Office (Picture 3).

These measurements indicate that when the furnace is activated, products of combustion are venting into the furnace room/basement, rather than out of the building via the chimney. Due to the holes around the heating pipes it is possible that products of combustion from the furnace are drawn into the treasurer's office from the ceiling of the Senior Center via the holes for the heating pipes that were noted in Pictures 3 and 4.

Heating pipes supplying the Treasurer's Office FCU; note space between pipes

7. Examine and repair the furnace casing to prevent furnace exhaust leakage.
8. Seal the spaces between heat vent pipes in Pictures 3 and 4 with a fire rated sealant. Seal both sides of these and any other pipe penetration in floors, ceilings and walls throughout STO.

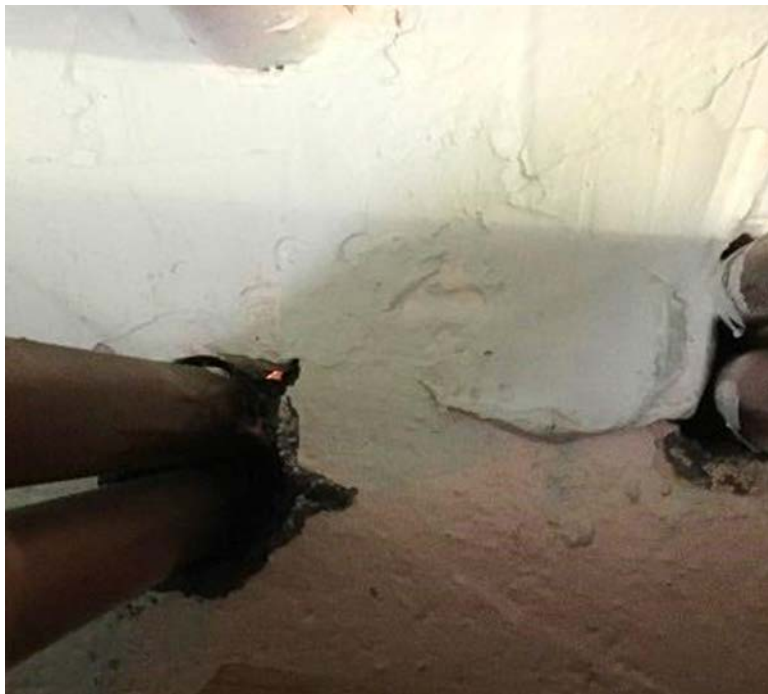
Picture 4

- The same heating pipes have a space that is open between the Senior Center above the kitchen cabinets to the furnace room (Picture 4).
- The flue connecting the furnace to the chimney has a hole (Picture 5).

Gaps between heating pipes penetrating wall between the senior center and the furnace room

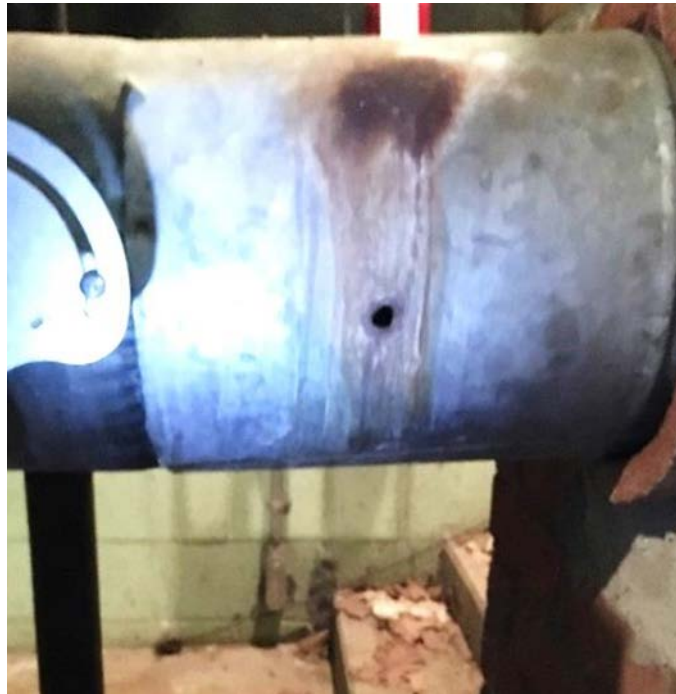
Picture 5

Hole in furnace flue

3. Ensure that the chimney is not blocked.
4. Seal the hole in the furnace flue.
5. Consult with a furnace company to identify the reason why the combustion air vent is equipped with the barometric pressure vent. If not required, remove the barometric pressure vent.

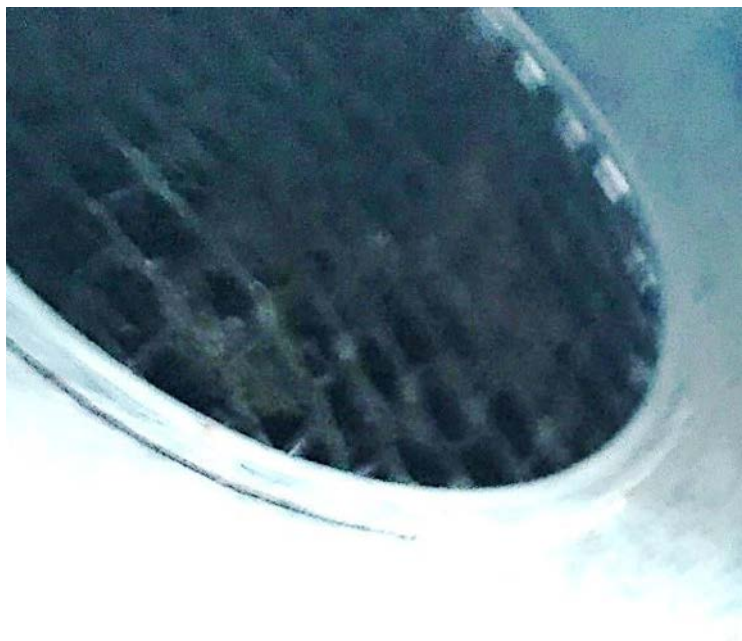
Picture 6

- The air intake for the furnace power vent was clogged with debris, including leaves, which would prevent combustion air from getting to the furnace (Picture 6).

Furnace power vent air intake clogged with debris

6. Ensure that the power vent fresh air intake is not blocked the debris. If possible, reconfigure the combustion air intake to prevent blockage by leaves and other debris.

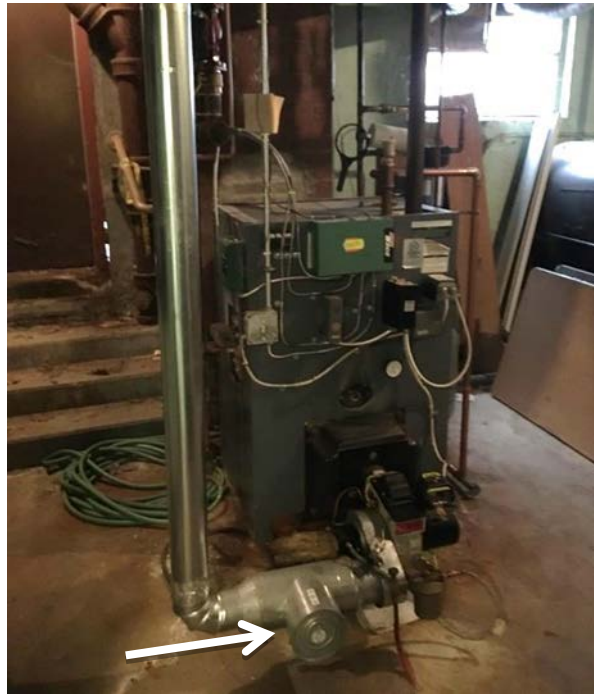
Picture 7

- A barometric pressure vent exists on the duct supplying the furnace power vent (Picture 7). If the combustion air intake is blocked, this vent would allow for combustion air to be drawn from the furnace room. This is an unusual configuration because without the barometric pressure vent on the flue between the furnace and the chimney this particular vent can allow for backdrafting of products of combustion into the building.

Barometric pressure vent on power vent duct
